BEARINGS

Ball, Tapered and Roller Bearings

11. BEARING DEFECTS AND DAMAGE

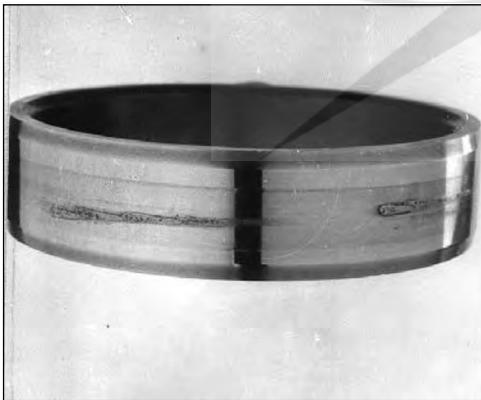
Fig. 11.1

Unacceptable tearing off of material due to thermal overloading of the bearing is shown in fig. 11.1 and 11.2.

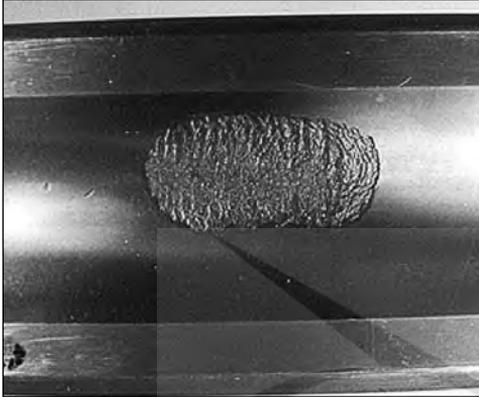
Fig. 11.3

Typical fatigue effect – pitting, which forms on the bearing rings, is shown on fig. 11.3 and 11.4. This damage is the result of cyclical loading of bearing components and is caused by normal fatigue of the material. The first cracks emanate from miniature non-homogeneities in the material at a particular depth below the surface. They are often, however, caused by overloading, insufficient lubrication, or other operating influences. Their timely identification can better help analyse and eliminate the cause. The figures illustrate unacceptable wear.

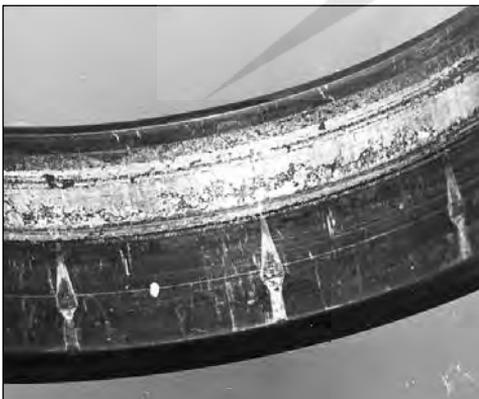
Fig. 11.5

Damage to bearing rings caused by indelicate installation (fig. 11.5) and shallow depressions in the race-way caused by beading of solid impurities during bearing operation (fig. 11.6). The extent of damage in both illustrated cases is unacceptable and may form the initial site of progressive fatigue damage – pitting. Damage to raceway caused by improper installation are usually easily discernible because they are located within the pitch of the roller elements. Pressure damage caused by stationary overloading or by equipment vibrations when transporting over long distances, e.g. during shipping, also present a danger.

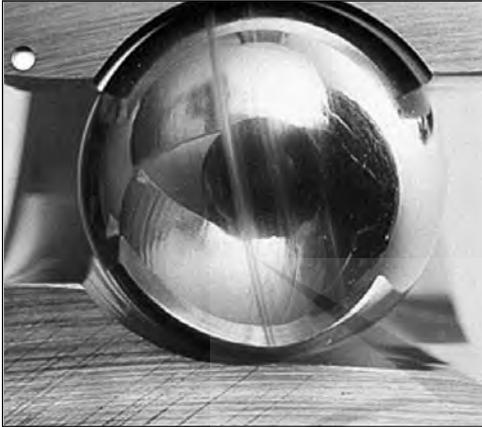
Fig. 11.7

Ball glazing due to overloading and lubrication failures (fig. 11.7) and abrasion of the race due to spinning within the seat (fig. 11.8). The condition in both cases is unacceptable.

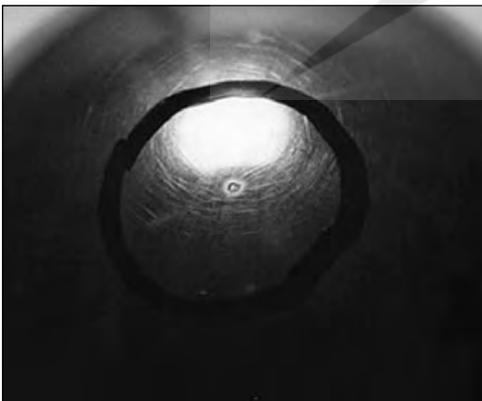
Fig. 11.9

Damage to the ball (fig. 11.9) and the raceway (fig. 11.10) by the passage of electric current through the roller contact. This type of damage is unacceptable. This forms when sparking occurs over a thin layer of lubricant. Burned-out cratering forms on such sites and are a source of bearing vibration and increased noise. This type of damage in motor housings and other roller-contact seats of rail vehicles with electrical traction are prevent, for example, by the use of bearings with an insulation layer on one of the rings and by the use of hybrid bearings with ceramic balls.

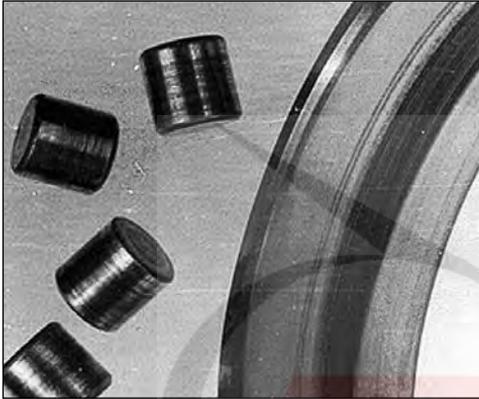
Fig. 11.11

Wear on the rolling surfaces of cylindrical rollers (fig. 11.11) and races (fig. 11.12) are caused by lubrication failure without flaking of material. Such damage may occur primarily in areas, where maintenance of the lubricating film is hindered, such as bearing ring faces or on roller faces. Undesirable wear may also occur due to slippage of rolling elements towards the bearing rings. Wear is characterized by traces of seizing and slippage, which is often accompanied by brownish spots on the raceway. This is unacceptable wear.

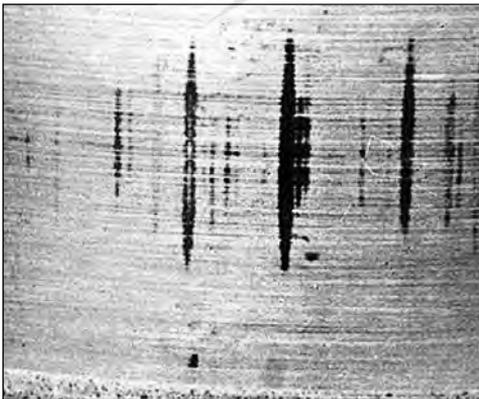
Fig. 11.13

The first picture (fig. 11.13) shows traces of acceptable contact corrosion on the raceway and the second (fig. 11.14) show inner ring corrosion. Corrosion resulting from inadequate protection against moisture or the use of an unsuitable lubricant is always impermissible. Areas affected by rust formation may progressively become initial sites of flaking of operating surfaces, which can lead to deteriorated operating precision and decreased bearing durability. Corrosion occurs when atmospheric moisture condenses, which can occur under improper
